DEPARTMENT OF TRANSPORTATION**DIVISION OF ENGINEERING SERVICES**

Quality Assurance and Source Inspection

Contract #: 04-0120F4Cty: SF/ALA Rte: 80 PM: 13.2/13.9File #: 69.15**SOURCE INSPECTION REPORT****Resident Engineer:**Siegenthaler, Peter**Address:** 333 Burma Road**City:** Oakland, CA 94607**Report No:** SIR-002890**Date Inspected:** 17-Jan-2011**Project Name:** SAS Superstructure**OSM Arrival Time:** 1500**Prime Contractor:** American Bridge/Fluor Enterprises, a JV**OSM Departure Time:** 300**Contractor:** Zhenhua Port Machinery Company, Ltd (ZPMC), Changxing Island **Location:** Shanghai, China**Quality Control Contact:** Mr. Don Walton**Quality Control Present:** Yes No**Material transfer:** Yes No N/A**Sampled Items:** Yes No N/A**Stock Transfer:** Yes No N/A**OK to Cut:** Yes No N/A**Rebar Test Witness:** Yes No N/A**Delayed/Cancelled:** Yes No N/A**Other:** Coating Inspection**Bridge No:** 34-0006**Component:** See Below**Bid Item:** 77, 78, 79**Lot No:** B #204**Summary of Items Observed:**

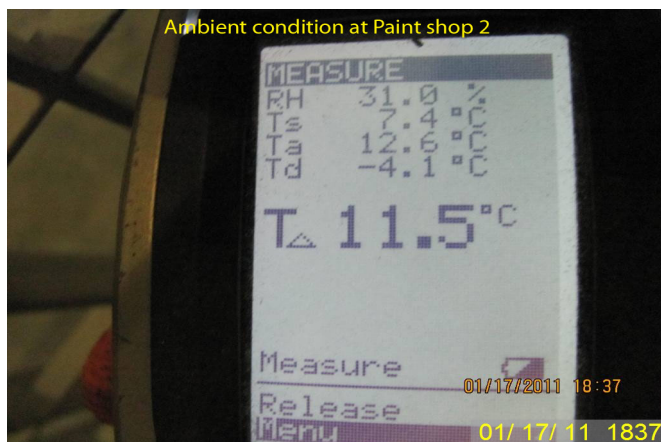
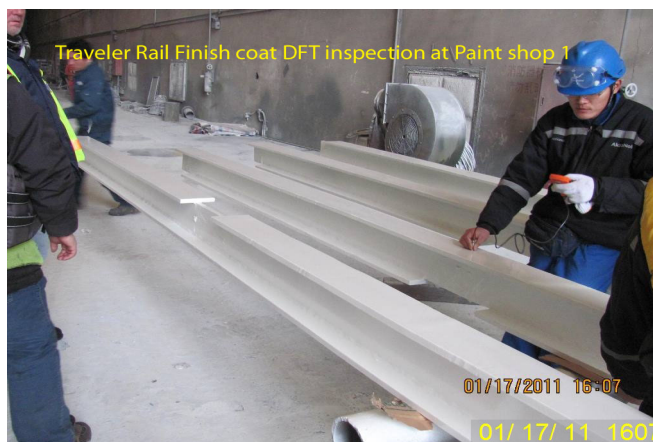
An inspection was requested on the Traveler rail -8 nos , vide inspection request no. 5805 for Final acceptance inspection at Painting shop 1. This QA inspector observed, ABF Inspector Mr. Shi Stone found inspecting these surfaces . This was found not accepted by ABF Inspector for Holidays in corner edges. It was found ZPMC offered these items again vide notification no. 5808. This QA inspector observed, ABF Inspector Mr. Sun found inspecting these surfaces . This was found accepted by ABF Inspector. Ambient conditions found measured by

An inspection was requested on the Breakwater plates, inspection request no. 5787 for DFT Check after Interzinc 22 application at Painting shop 2. This QA inspector observed, ABF Inspector Mr. Shi Stone found inspecting these surfaces . This was found not accepted by ABF Inspector for High DFT which was found more than 200 microns. It was found ZPMC offered these items again vide notification no. 5809. This QA inspector observed, ABF Inspector Mr. Sun found inspecting these surfaces . This was found accepted by ABF Inspector after Observing DFT in the range of 96 to 150 microns. International protective coatings technical service representative Mr. Andy was found present during the coarse of this inspection process for Technical discussion.

During the final acceptance Inspection prior to transport from workshop to Ship of Traveler rails, This QA Inspector observed DFT of Interfine 979 at Web was more than 450 microns at some places. This was discussed with Mr. James Lumley and was clarified. As per him, When the applied system is uniform,homogenous,and continuous as has been in the past and it is not detrimental to the performance of the applied system.
